# **EROSION STUDY OF 7.62MM CR-MO-V STEEL GUN TUBES**

**PART I. Erosion Analysis and Characterization**

**PART II. Fatigue Behavior in Reactive Environments**

## **TECHNICAL REPORT**

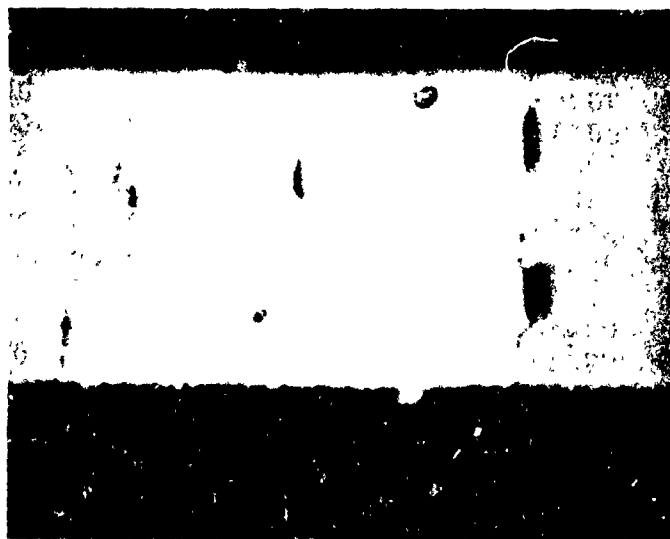
FIGURE 2. Inherent defects in chromium plating.

(b) Photomicrograph of Cr plating on unfired barrel. Etched - 4% nital, 500X.

Cracks were inherent in the hard chromium plating on the bore (Figure 2). The decomposition of the initially deposited chromium hydride is believed to be responsible for the presence of high stress in the deposit. During transformation to stable body-centered cubic chromium, a volume contraction of up to 15% takes place. The Cr layer first grows a certain thickness and then cracks form because of the high tensile stress.<sup>2</sup> The thickness of the plating was nominally 2.5 mils, and the hardness was approximately Rc 66-70. After one round, the cracks became more obvious in the plating; repeated firing continued to expand the initial cracks and also created new ones.

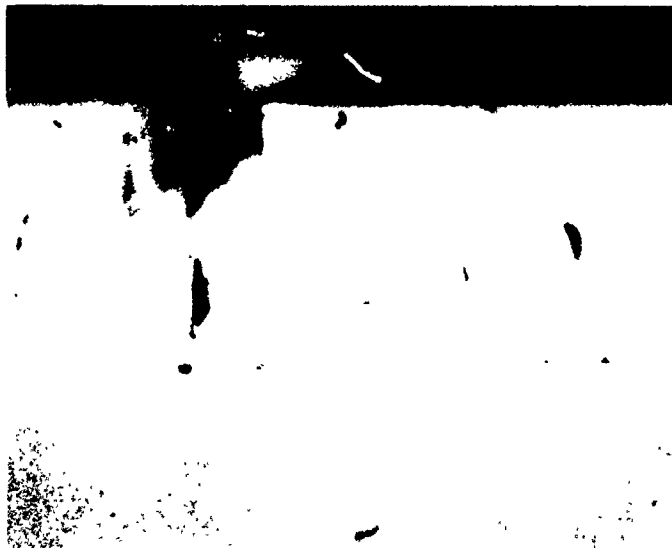
FIGURE 3. Pits developing in steel at base of cracks in Cr plating. Barrel C-10.

(a) Photomicrograph, transverse section. Unetched, 500X.

(b) Scanning electron micrograph. Nital etch. 10,000X.

The first evidence of any alteration appeared at the Cr-steel interface after only ten rounds, as is shown in Figure 3. These pits were always observed to be associated with cracks in the plating, but all of the cracks did not result in pits. This pitting condition had not significantly changed after 50 rounds; however, an almost complete absence of pitting was observed on the barrel fired for 100 rounds. An X-ray spectrometer analysis of a pit in barrel C-50 (Figure 4) showed Pb, Ca, and possibly P to be present. The presence of P was also indicated in the pits in barrel C-10. Bore surface samples from barrel C-100 did show extension of cracks into the steel which is depicted in Figure 5. After 100 rounds, the chemistry of the bore surface, Figure 6, included aluminum, lead,\* sulfur,\* calcium, copper and zinc. No foreign elements were detected in the fine cracks of the C-100 barrel.

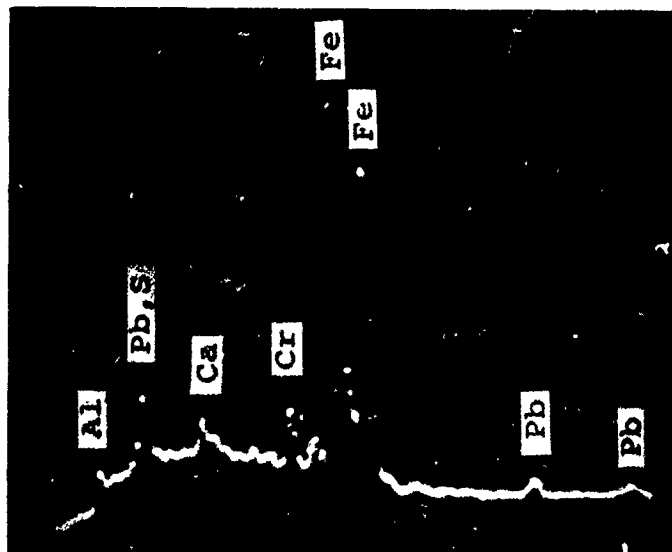
FIGURE 10. Chemical analysis in crack leading from pit at location indicated by white dot in top photograph. Barrel C-200.

(b) X-ray spectrometer results.

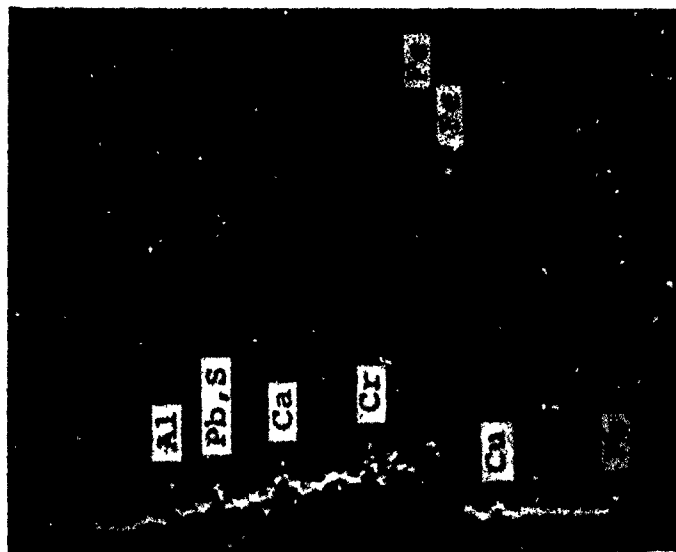
FIGURE 14. Chemical analysis of crack (white dot) in barrel C-2100. Analysis in reaction zone (black dot -- not shown) yielded no foreign elements.

(a) Branch crack and reaction zone as it appeared in transverse sample. Scanning electron micrograph, unetched 3000X.

(b) X-ray spectrometer analysis.

Cracking and associated reaction zone formation continued through 1500 rounds and appeared as shown in Figure 14 after 2100 rounds. Analysis of this fine crack surrounded by reaction zone resulted in finding the foreign elements at the very tip of the crack, but analysis in the reaction zone provided a chemistry identical to that of the base steel. Granular removal of the Cr plating resulted in cavities in the bore surface that can be seen in Figure 15.

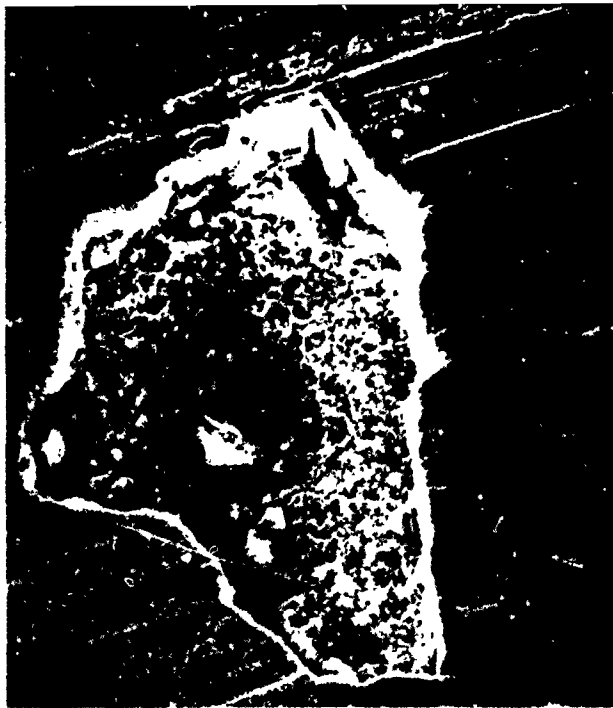
FIGURE 15. Scanning electron micrographs of hole left  
in bore of barrel C-2100 after Cr removal.  
Top-300X, Bottom-1000X.

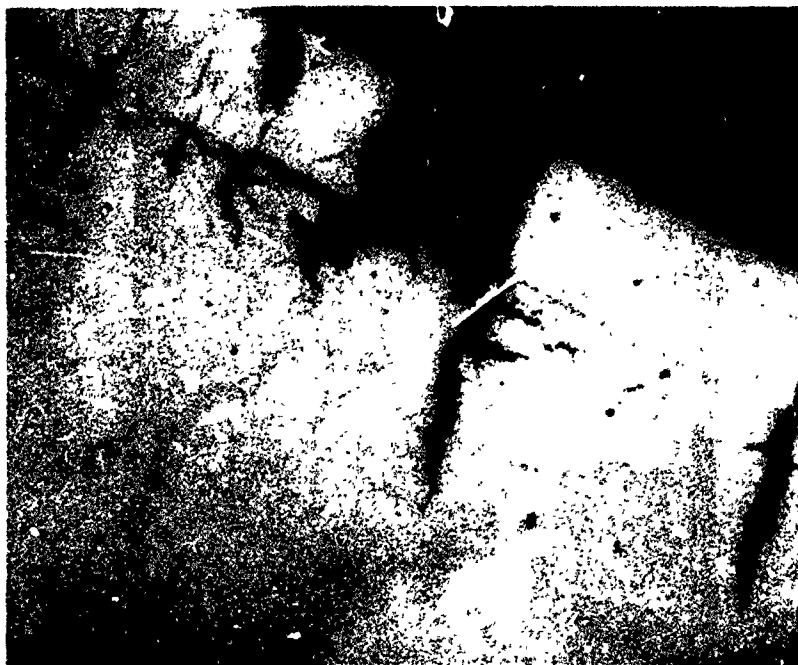
FIGURE 17. Photomicrographs capturing the condition of cracking representative of barrel C-3000.

(a) Poor condition evident on transverse section. Unetched, 250X.

(b) Crack in early stages of formation. Transverse section, nital etch, 1000X.

microscope as is the reaction zone which is more prominent in the finer cracks. Both the progressed stage of cracking and Cr removal, and the continuing formation of new cracks at the base of the inherent defects in the plating are shown in the photograph of Figure 17. The nature of the barrel deterioration more distant from the origin of rifling is shown in Figure 18. The tense teardrop-shaped reaction zones were characteristic of the defects found in this area.

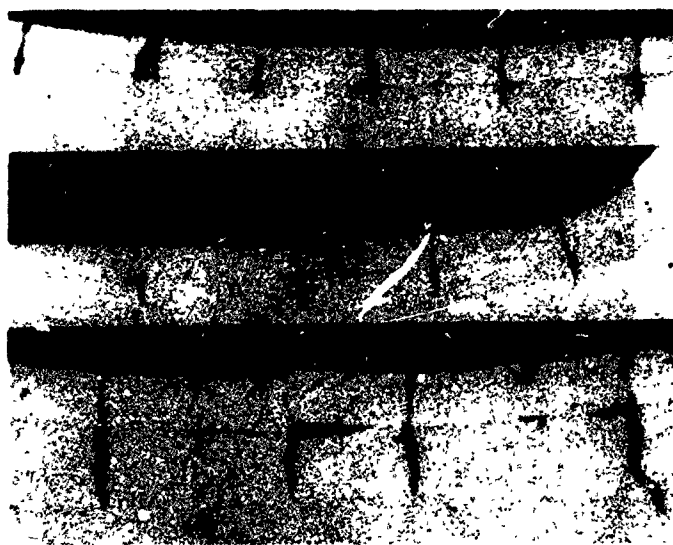
FIGURE 19. Crack progression in Cr plated barrels.  
Transverse samples, 100X. Top C-900,  
Middle C-1500, Bottom C-3000.

The progression of cracking as a function of the number of rounds fired is depicted in the composite photograph of Figure 19.

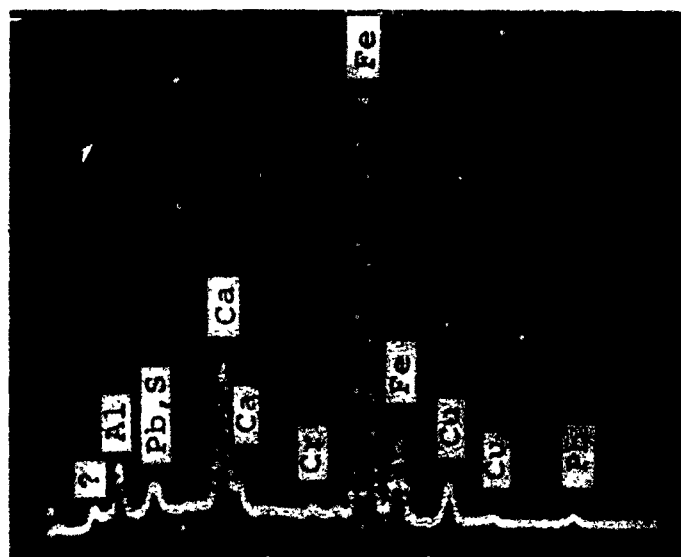
FIGURE 30. Chemical analysis of bore surface of barrel U-3000 (Figure 27).

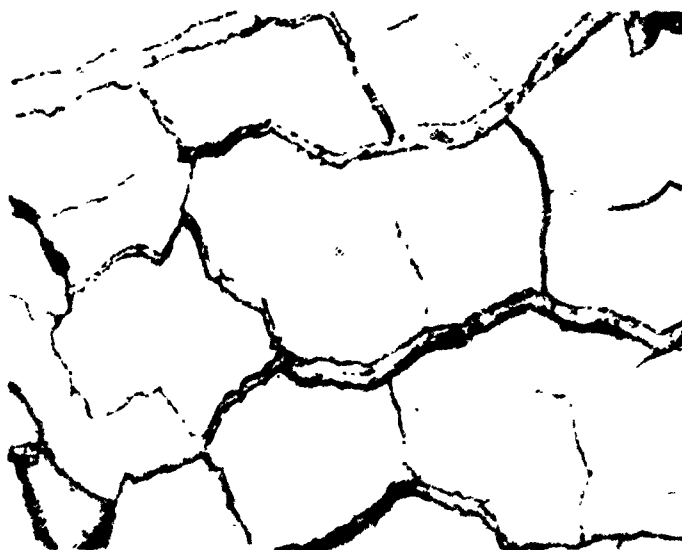
FIGURE 34. Copper deposits in incoherent Cr plating.

(a) Photomicrograph showing Cu throughout cracks in Cr plating. 100X.

(b) Copper assisting in Cr grain removal by wedge effect. Scanning electron micrograph, 300X.

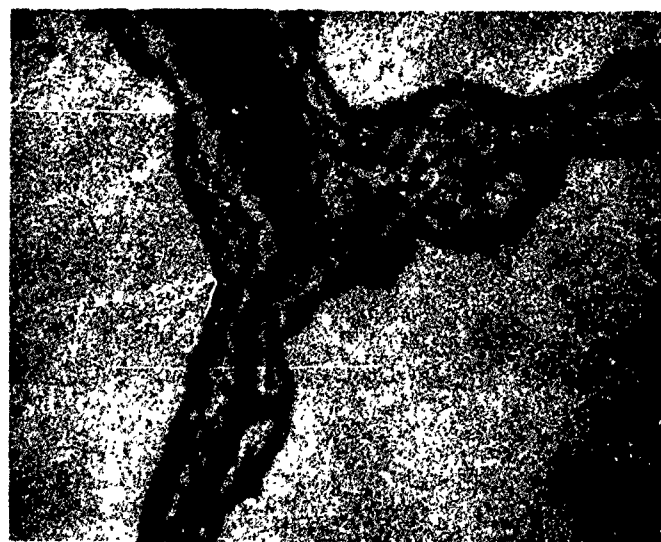
FIGURE 35. Reaction zone in severely eroded barrels.

(a) Scanning electron micrograph 3000X.

(b) Photomicrograph, 800X.

The reaction zone was predominant in these barrels. Figure 35 clearly reveals the zone to be made of two phases (one white, one gray). The delineation of the two phases was usually not as definite as in Figure 35(a), but more commonly is a porous mixture like that shown in Figure 35(b). Microhardness determinations in the reaction zone resulted in the data included in Figure 36. A load application of only 25 grams was used to ensure attainment of an indentation wholly within the reaction zone. Several other readings were taken in the reaction zone and the average Knoop Hardness was determined to be 1075, considerably harder than the base Cr-Mo-V steel. In addition, Figure 36 shows the hardness increasing with proximity to the crack and reaction zones -- this effect was not observed in all tests.

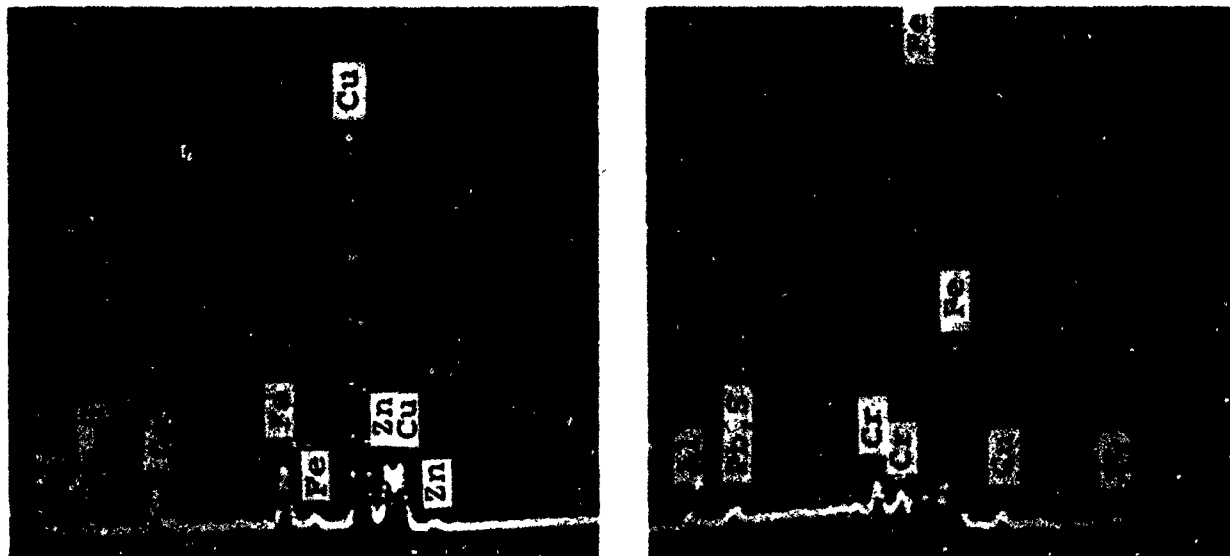
FIGURE 37. Chemical analysis of Cu filled crack and reaction zone in severely eroded barrel.

(b) X-ray spectrometer results - crack (left) and representative of reaction zone (right).

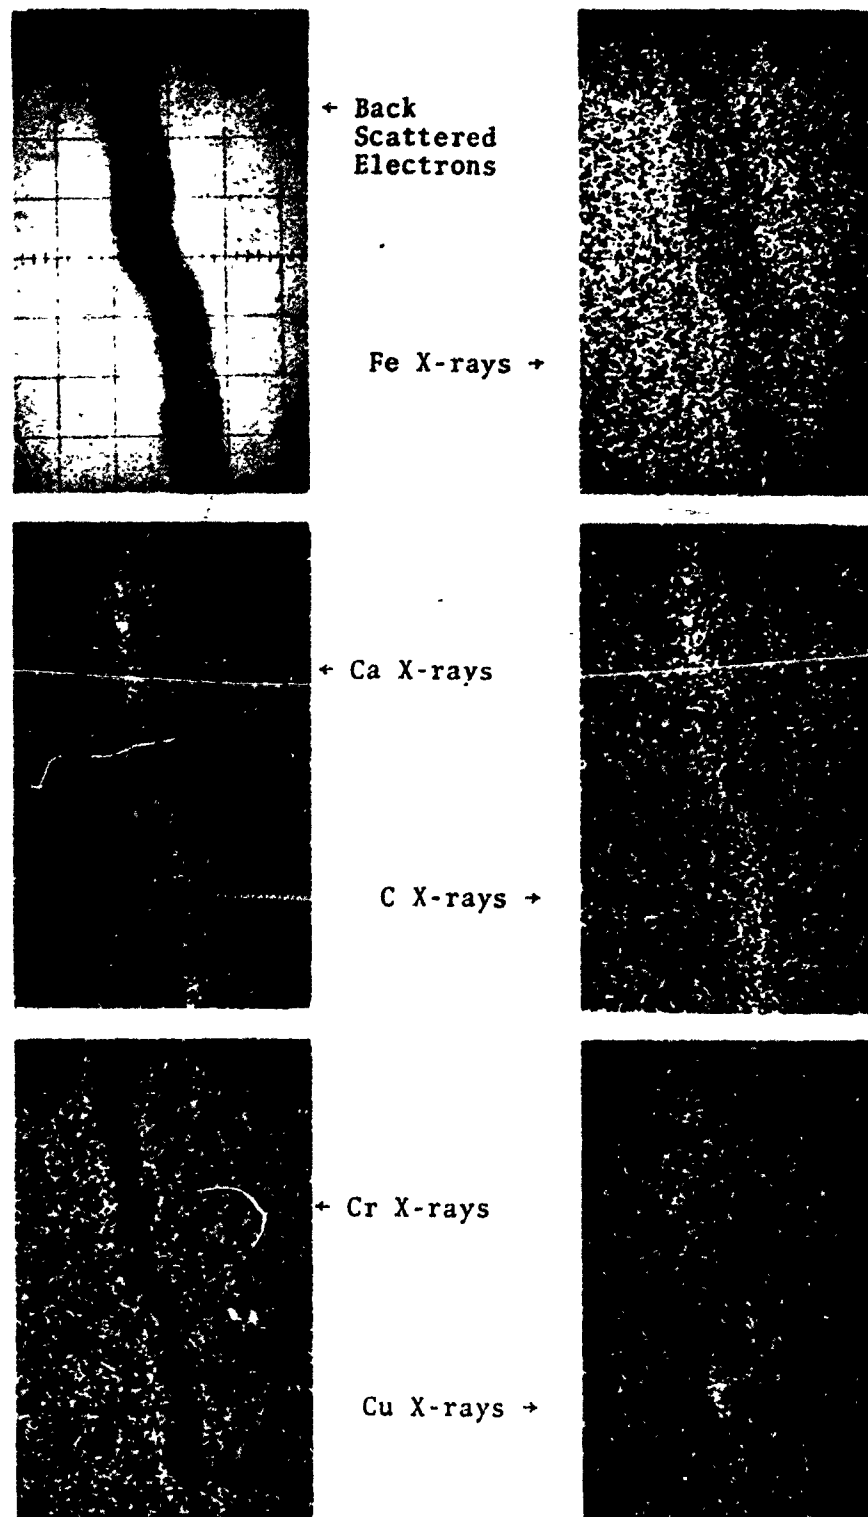
FIGURE 40. Electron microprobe analysis of crack and reaction zone in severely eroded barrel. 1000X.

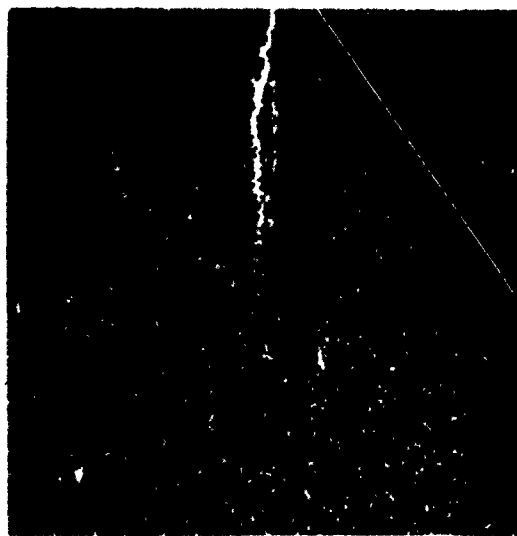
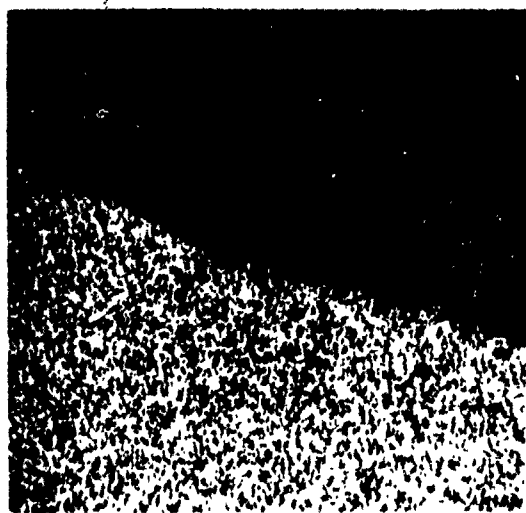
FIGURE 41. Electron microprobe analysis of a hemispherical shaped reaction zone in the steel at the base of an existing crack in chromium plate. (1000X)

Cr X-rays  
Note crack in Cr plate

Cu X-rays  
Cu filling Cr crack

Fe X-rays  
Note area of reaction zone  
beneath Cr crack

C X-rays  
Increase in C in reaction  
zone at base of crack  
in Cr

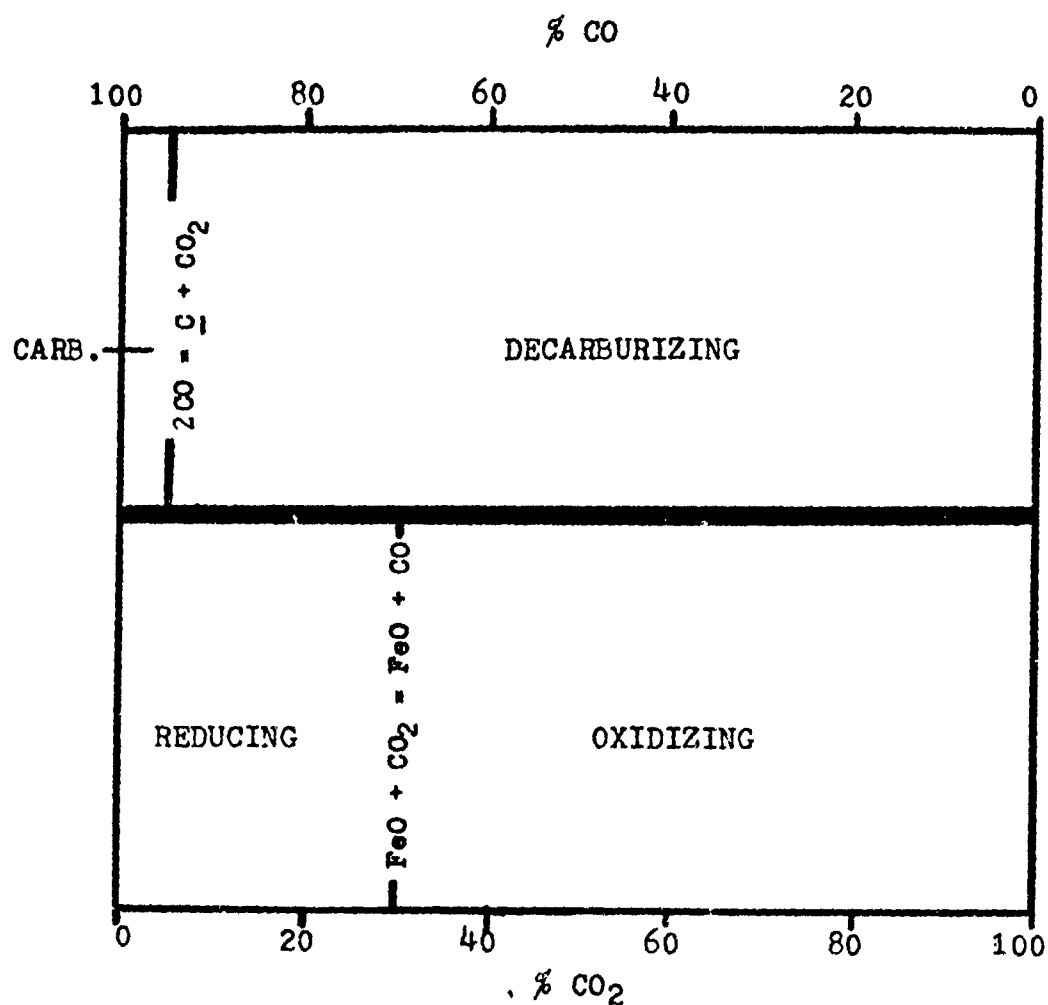
FIGURE 43. Reactions of iron with CO/CO<sub>2</sub> atmospheres.<sup>8</sup>

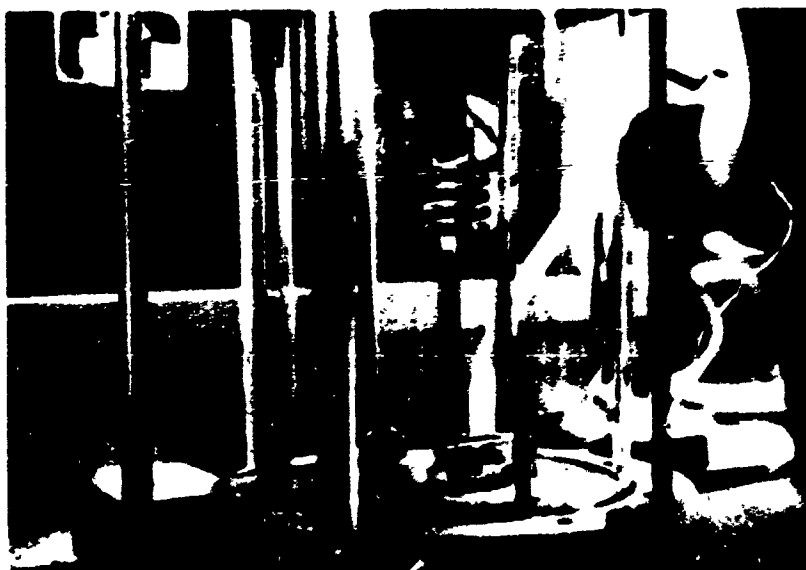
FIGURE 47. Induction coil with specimen at 1000°C.

A high frequency (450 kc) generator equipped with a saturable core reactor for output control coupled to a suitable coil provided for induction heating of the specimen. The generator was a Lepel Model T-5-3-KC-J-B with a maximum rated output of 5 KW. The coil used for heating the specimen was made from 3/10" O.D. copper tubing and contained four turns distributed over a total length of 1-1/4 inches. The coil is shown in Figure 47 with a heated specimen at 1000°C. The representative temperature profiles for the specimen are shown in Figure 48.

The extent of travel, i.e., the stress amplitude, was controlled by the stops in the fixture attached to the bottom plate of the test chamber, Figures 46 and 47. The maximum stress can be calculated by:

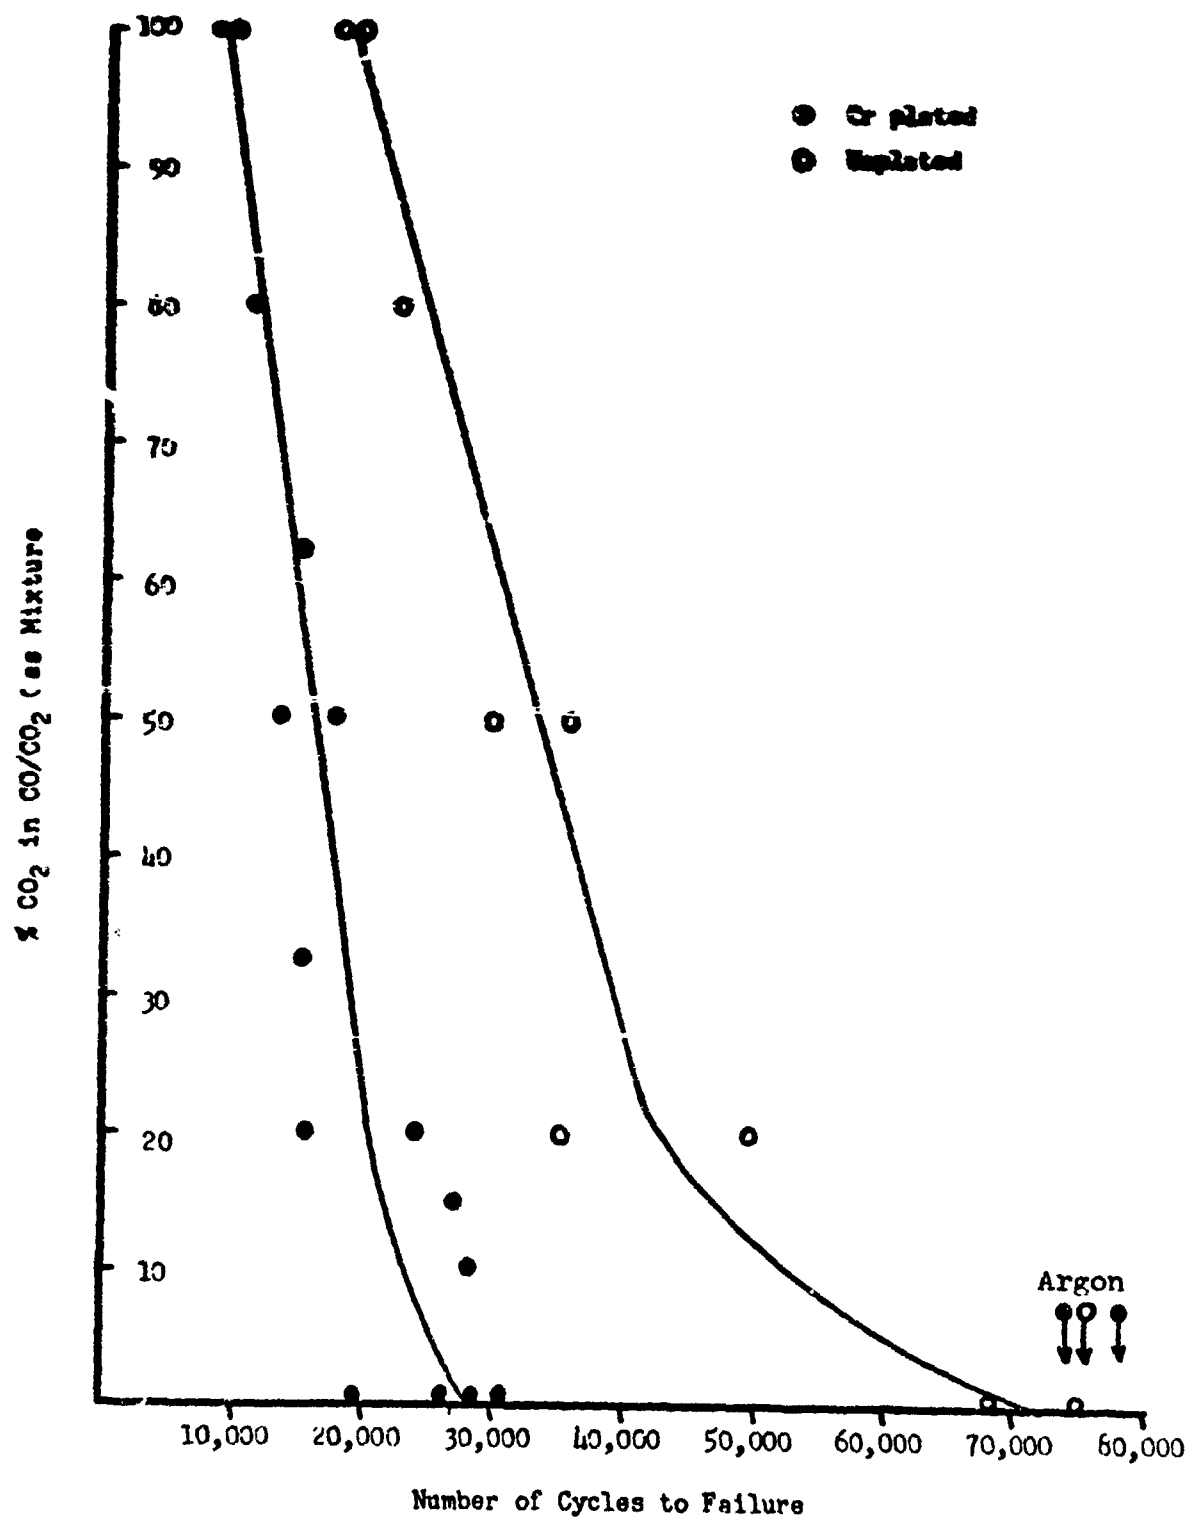
FIGURE 53. Plot of fatigue life as a function of gas composition.

The oxygen potential of the gaseous environment was shown to affect the cracking tendency. Certainly, a low oxygen potential is desirable for minimizing deterioration of the barrel. Undetermined factors such as pressure, temperature, and gas composition which exist in the barrel make exact correlations to laboratory results impossible.

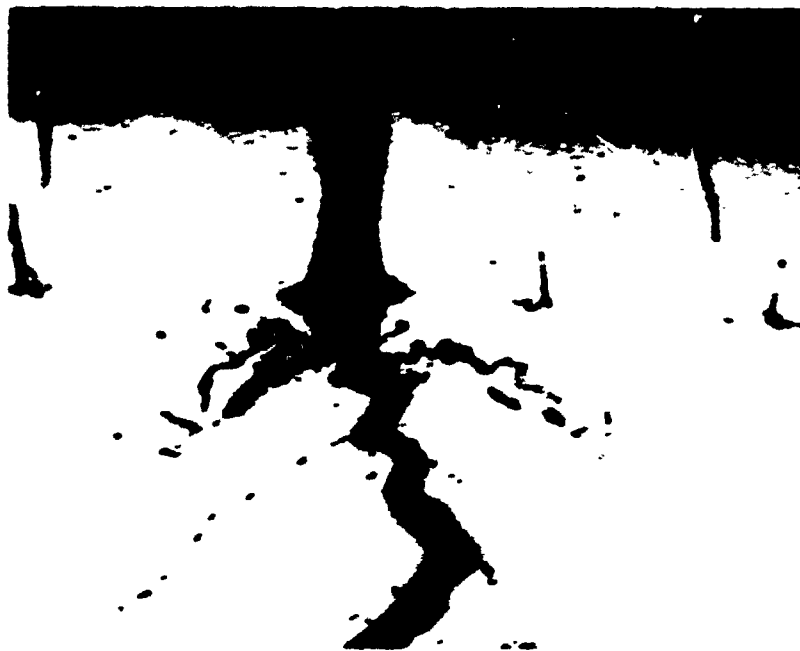
FIGURE 58. Crack propagation in the absence of pitting in Cr plated specimen. 500X. 50% CO<sub>2</sub>.

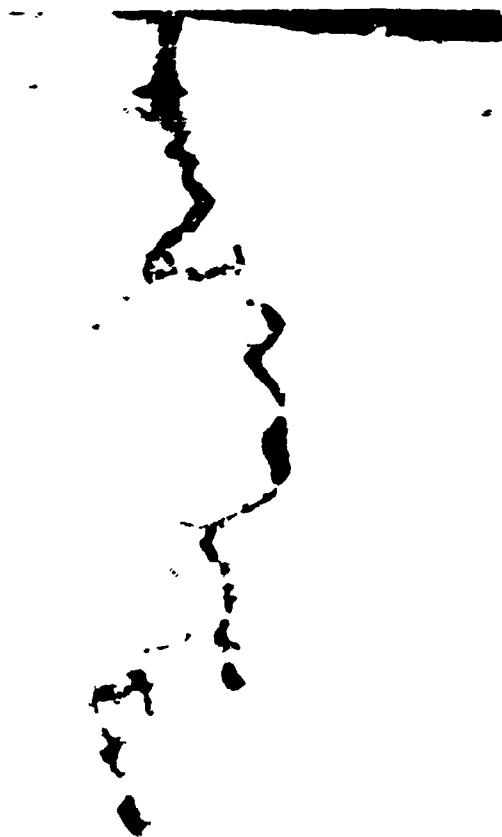
FIGURE 59

Same as above. 200X.

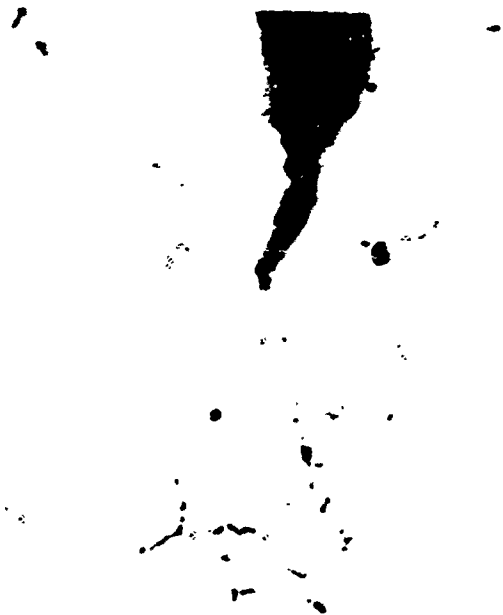
FIGURE 61.

Intergranular formation  
of precipitate in mottled  
zone formed at crack tip.  
750X.

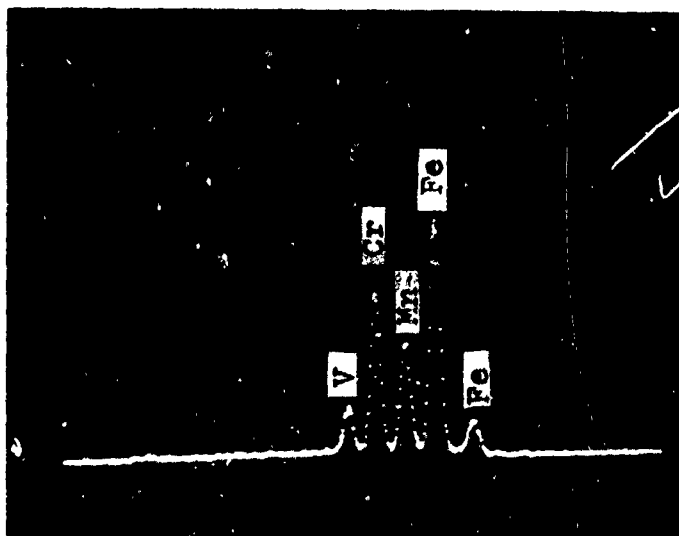
FIGURE 66. X-ray spectrometer analysis of precipitate particles in mottled zone.

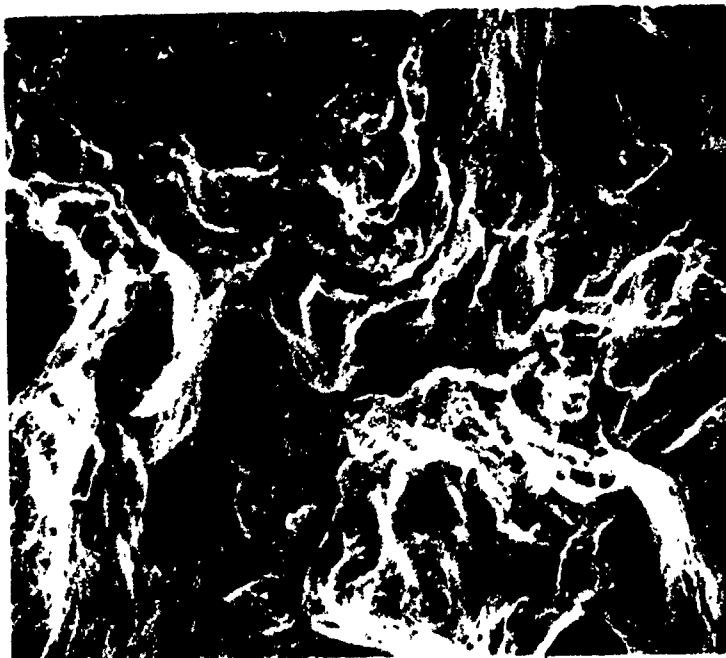
FIGURE 70. Scanning electron micrograph of fracture surface topology. 20% CO<sub>2</sub>. 300X.

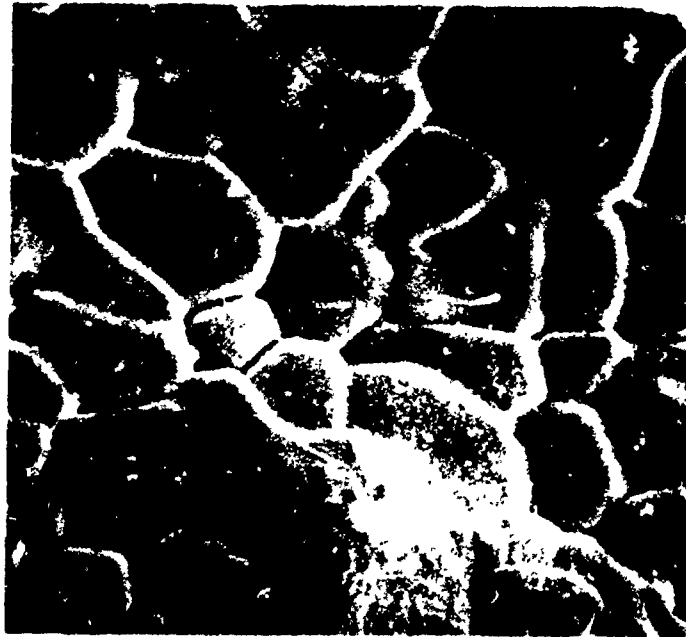
FIGURE 71. Scanning electron micrograph of copper film over fracture surface. Note copper penetration decorating grain boundaries. 600X.

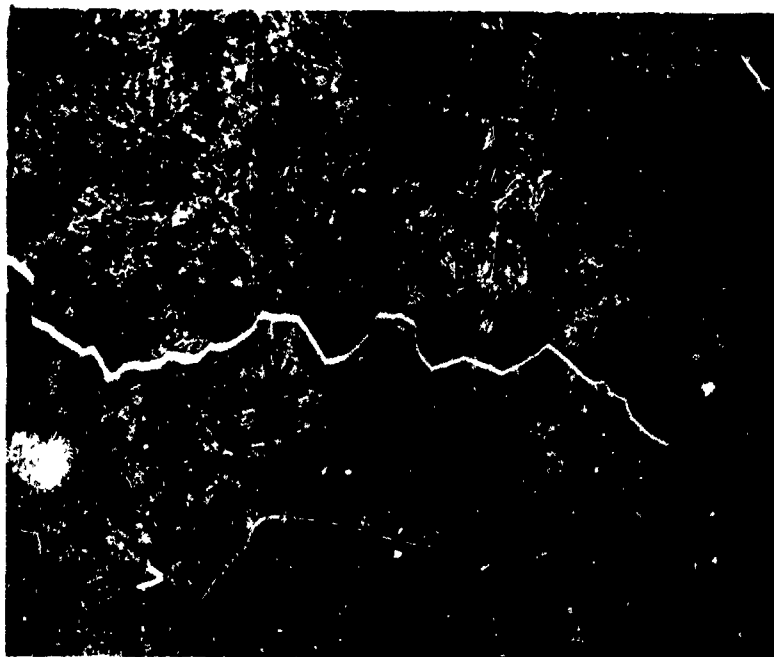
FIGURE 72. Photomicrograph showing liquid Cu penetration which led to rapid failure. Penetration perpendicular to surface of specimen. 150X.

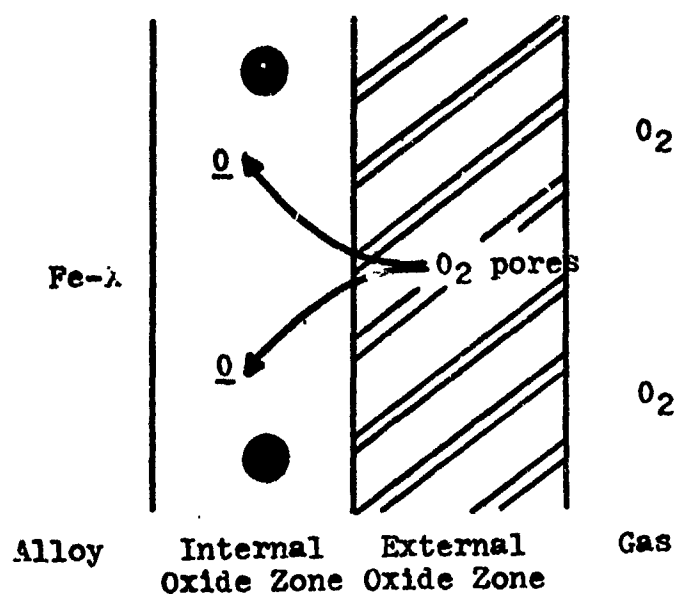
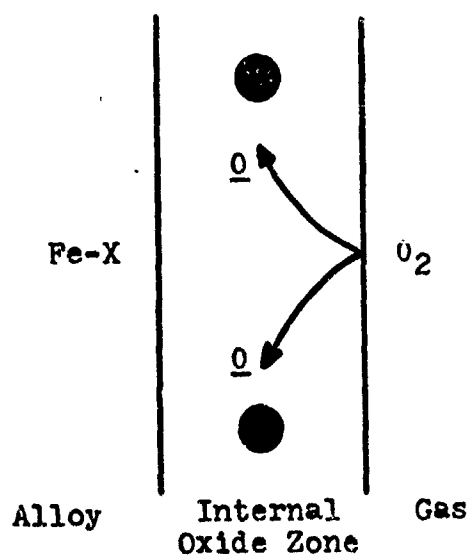
FIGURE 73. Representation of internal oxidation.  
(After Rahmel<sup>36</sup>)
